QUALITY ASSURANCE INSPECTION

Project: Ouzinkie Bulkhead OUZ 100801				Report No: 009		
Project Number: 091120				Date: March 30, 2012		Shift: Day
Consultant: PND Engineers, Inc. (907) 561-1011				Day of the Week: Friday		
WEATHER	Bright Sun	Clear X	Overcast	Rain	Snow	Other
TEMP (F)	Below 0	0-32	32-50 X	50-65	65-80	80+
WIND (mph)	Still 0-10 X	Mod 10-20	High 20+	Comments: Calm		
TIDE (ft)	High 7:08 AM +7.3'		Low 2:15 PM +1.5'	Comments: No waves		
<u>Name of Contractor</u>		<u>Supervisors</u>		<u>Manual</u>		<u>Remarks</u>
West Construction (West)		2		6		
CONTACTS						
<u>Name (first and last)</u>		<u>Title/Employer</u>		<u>Phone No.</u>		<u>Remarks</u>
Jim McHone		Superintendent, West		907-680-2289		
Dan Clarion		City of Ouzinkie, Mayor		907-680-2209		
FIELD ACTIVITIES						
<p>Work started at 7AM. West's pile crew repaired the coating on top of the pin piles and installed the fourth and final fender. It took some grease to get the energy absorbers to slip in between the keeper plates. As with the first three fenders, the nuts remain to be tightened to complete installation.</p> <p>The weld crew continued fabrication of the bollards. Bollard three was completed with the base plate

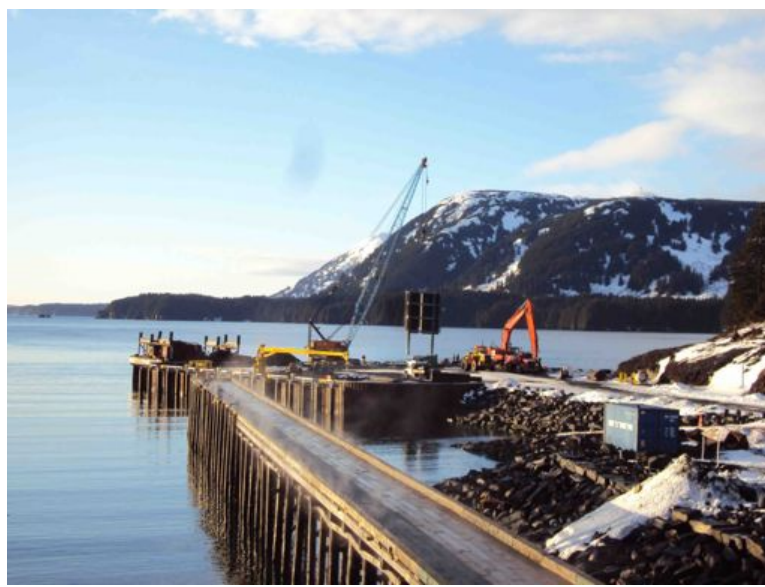
Photograph No. 1

Installing the fourth fender.

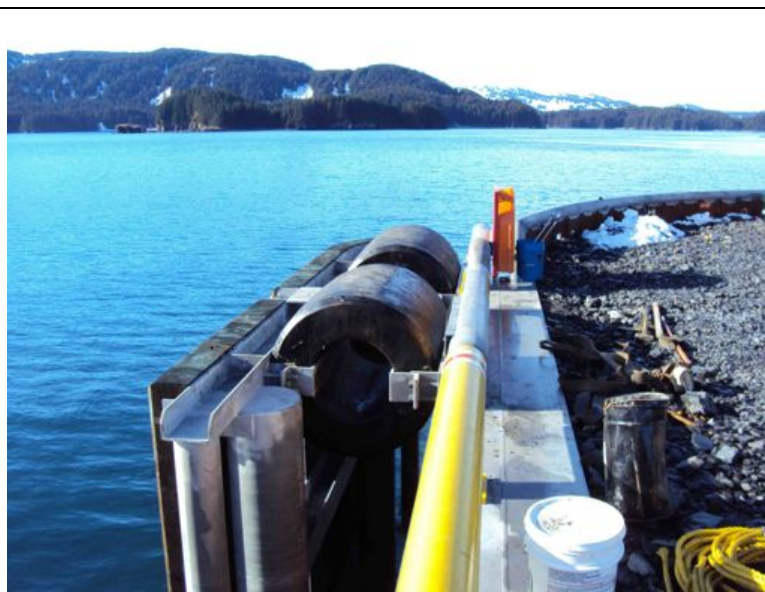
Photograph No. 2

Fender 4 in place.

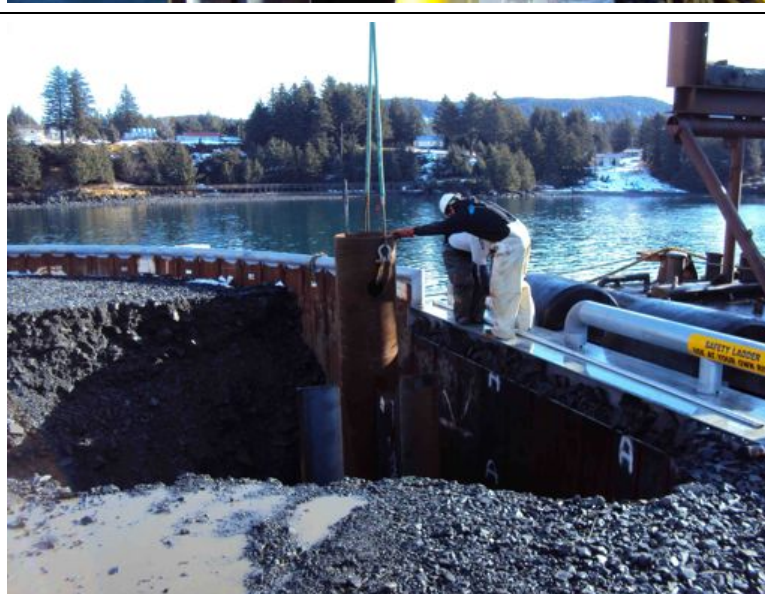
Photograph No. 3

The first bollard being placed.

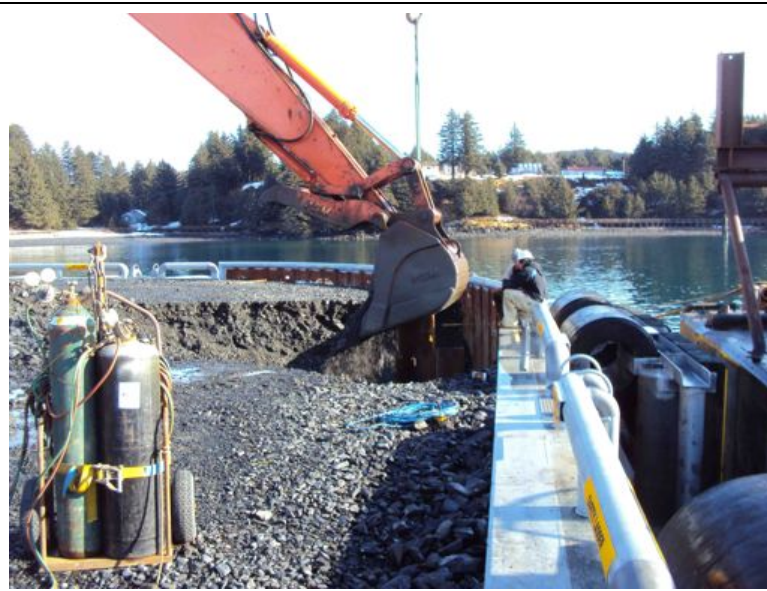
Photograph No. 4

Placing fill around the first bollard.

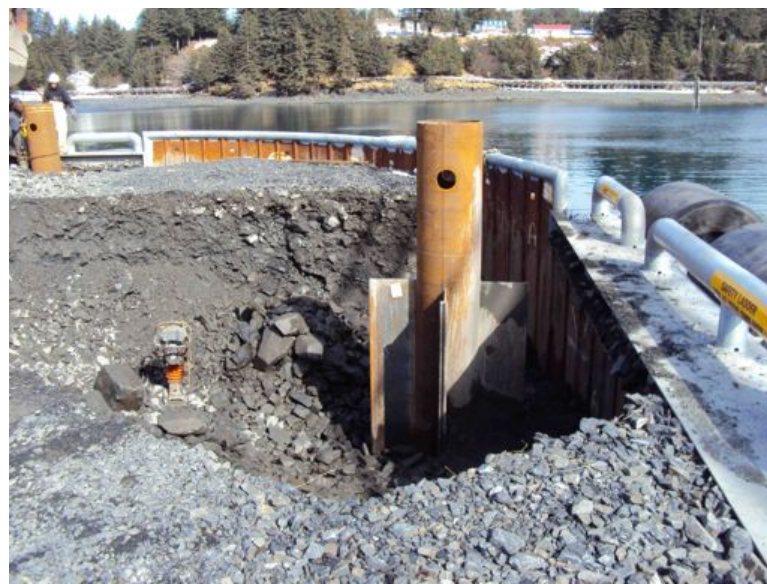
Photograph No. 5

First bollard with fill compacted by excavator.

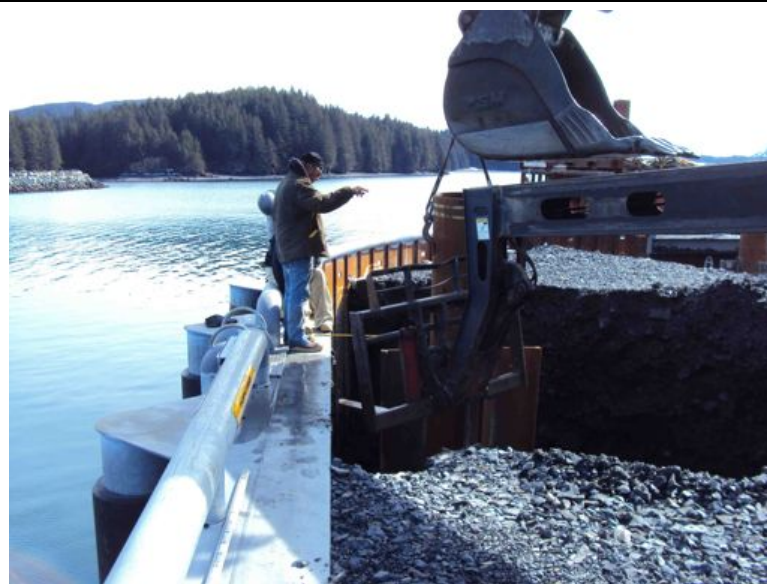
Photograph No. 6

Placing the second bollard.

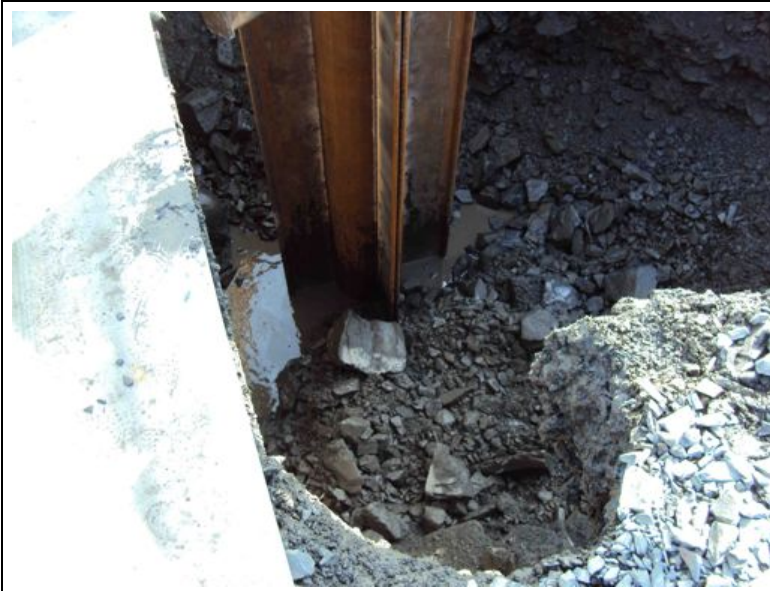
Photograph No. 7

Fill placement around second bollard.

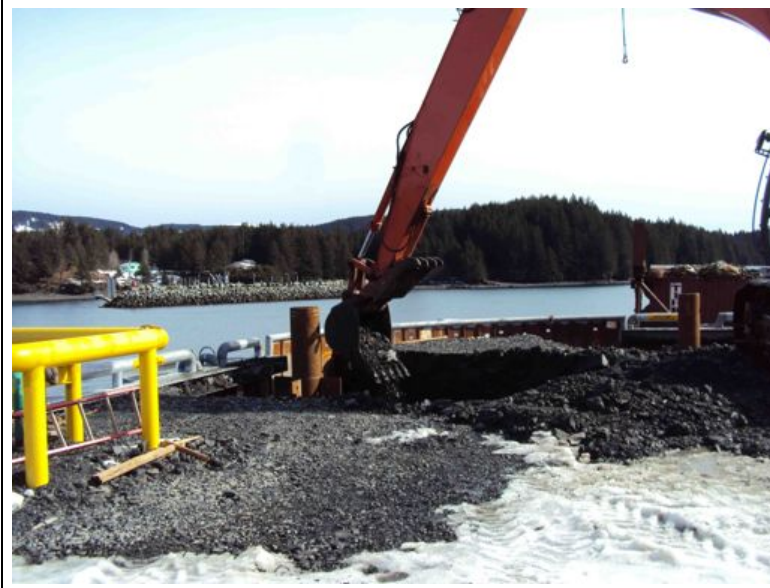
Photograph No. 8

Fill placement around second bollard.

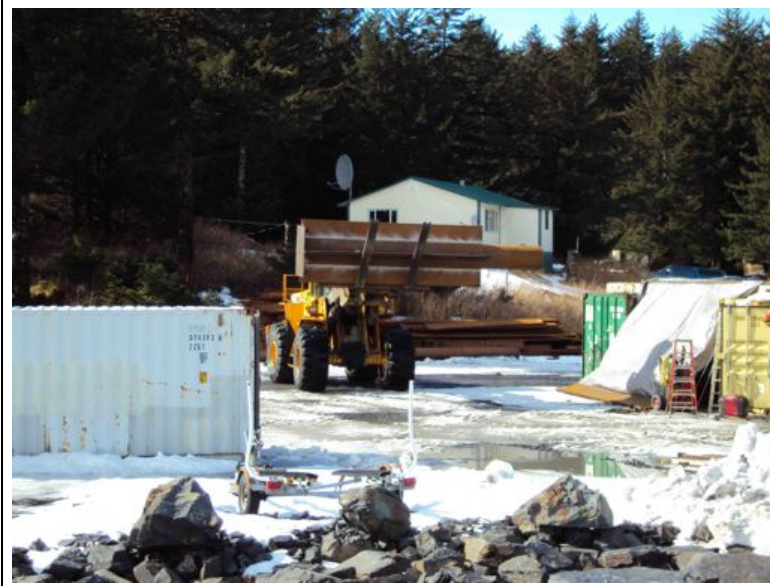
Photograph No. 9

The third bollard emerging from the fabrication shop.
